# **An Assessment of Streambank Stabilization and Riparian Restoration Efforts at Buffalo National River, Arkansas**

**Prepared By:**  
**David N. Mott, Hydrologist**  
**and**  
**Tony Collins, Hydrologic Technician**  
**National Park Service**  
**Buffalo National River**

February, 2002

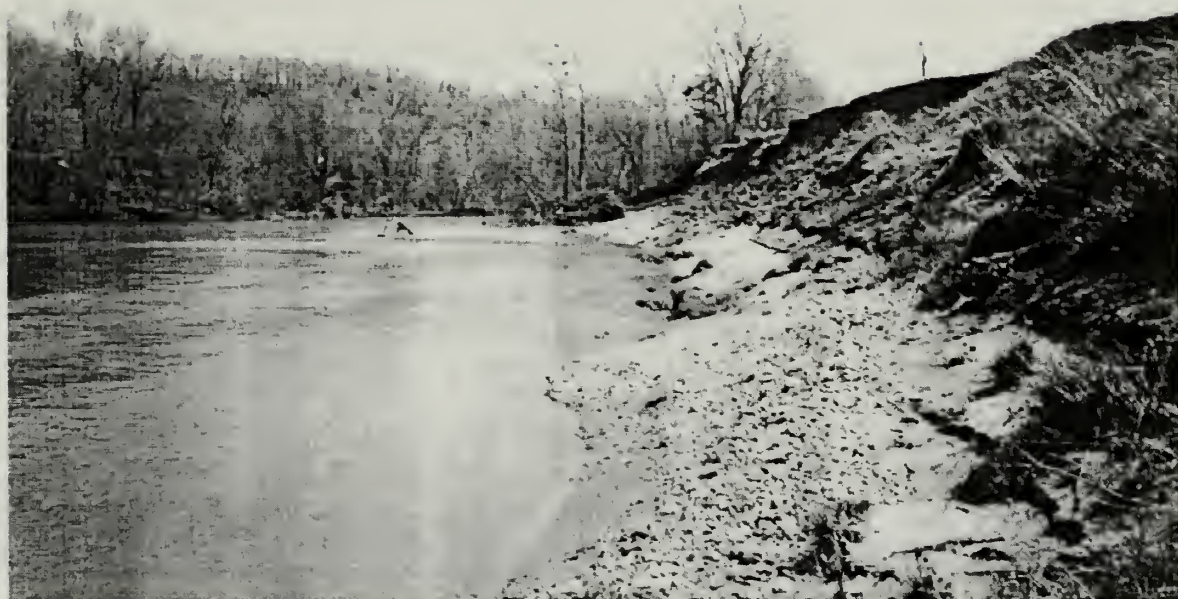
This site is located on the main channel of the Buffalo River across the river from the Baker Ford public access and canoe launch area. Bank height averages 24 feet from toe to flood plain level. The length of the bank is 1,000 feet with the lower 500 feet in what appears to be the active zone. Slumping is the dominant erosion process. Rill erosion is also apparent as flood plain drainage rushes down the face of this scarp. There is a bluff with a well vegetated bar on the opposite shore. This bar may be aggrading as the channel is widened due to erosion. Just downstream from the bank on the opposite side is the Baker Ford access which has a very gentle slope and low bank height but is well vegetated and appears to be very stable in spite of the fact that it is on the cut bank side of the river. About half way up the lower bank is a zone of cemented sand that appears to be acting as an aquiclude, keeping moisture in the upper portion of the bank and probably encouraging the slumping process. The bed is dominantly gravel with cobbles interspersed. The bank is dominantly composed of homogenous sand. As determined from the aerial photographs the erosion rate is 5 feet per year. Ground based erosion monitoring indicates erosion rates have slowed from 1985 - 1991, but this is a result of the erosion being propagated downstream and beyond the zone originally included in the monitored reach. The riparian corridor that was visible in this area on the 1972 aerial photographs (stream-side trees) has been removed by the slumping process which extended behind the streambank and into the flood plain. Stream side vegetation is present both above and below the eroding bank and is trying to recolonize the upper portion of the slump bank. The downstream vegetation is being heavily impacted by the ongoing erosion and slumping and scour around the base of the remaining trees is propagating the erosion in the downstream direction. Continued access by cattle is interfering with the ability of vegetation to re-colonize those sections of the bank which are trying to stabilize on their own.

**Photo 28: View downstream of Baker Ford Site (1994).**

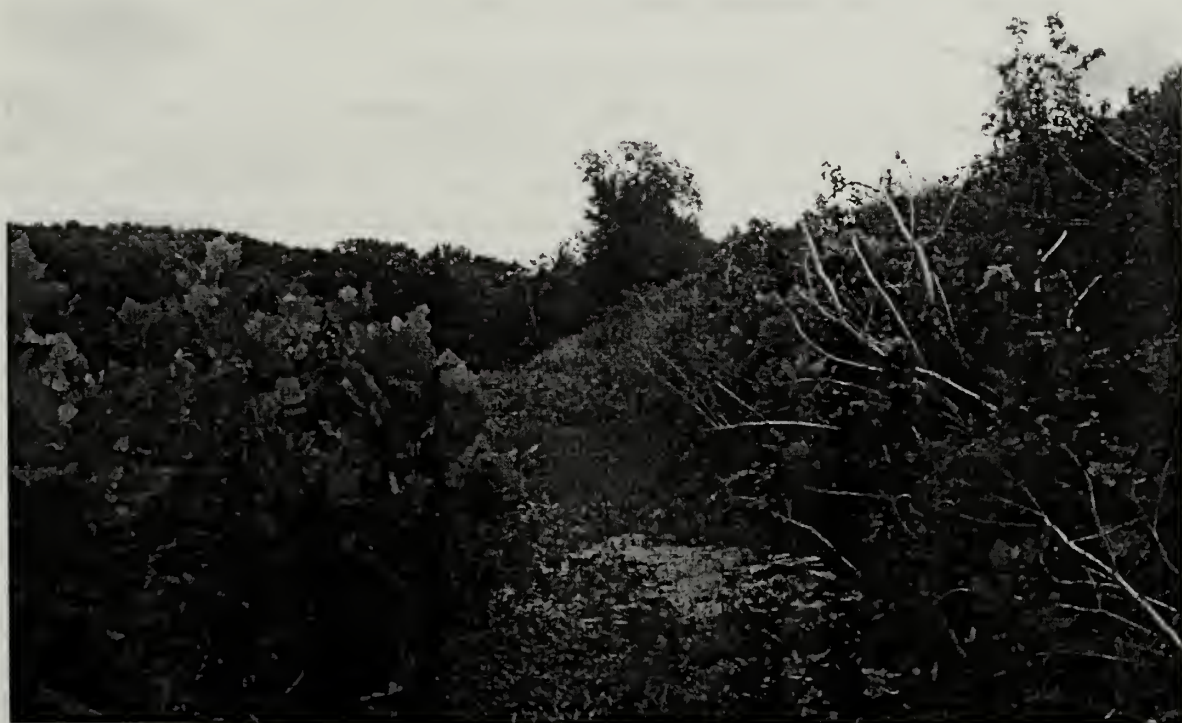
**Photo 29: View downstream of Baker Ford Site (2000).**

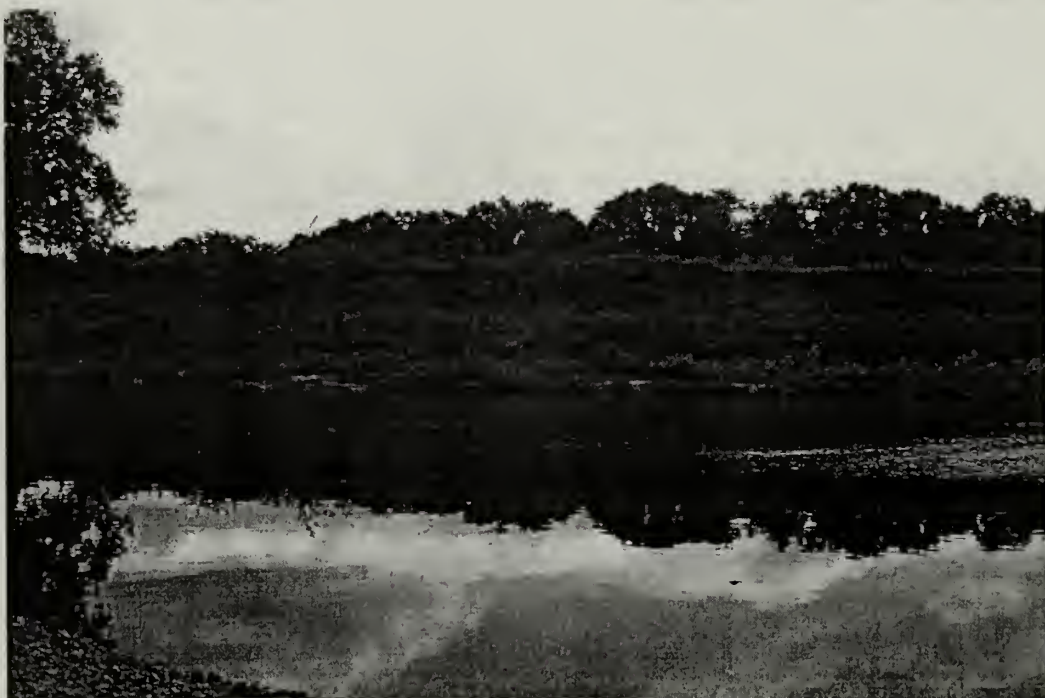
**Lower Third** – This portion is the most stable. There are trees and annual vegetation on the bank above the revetment as well as in and below it.

**Photo 30: View from across stream of Baker Ford Site (2001).**

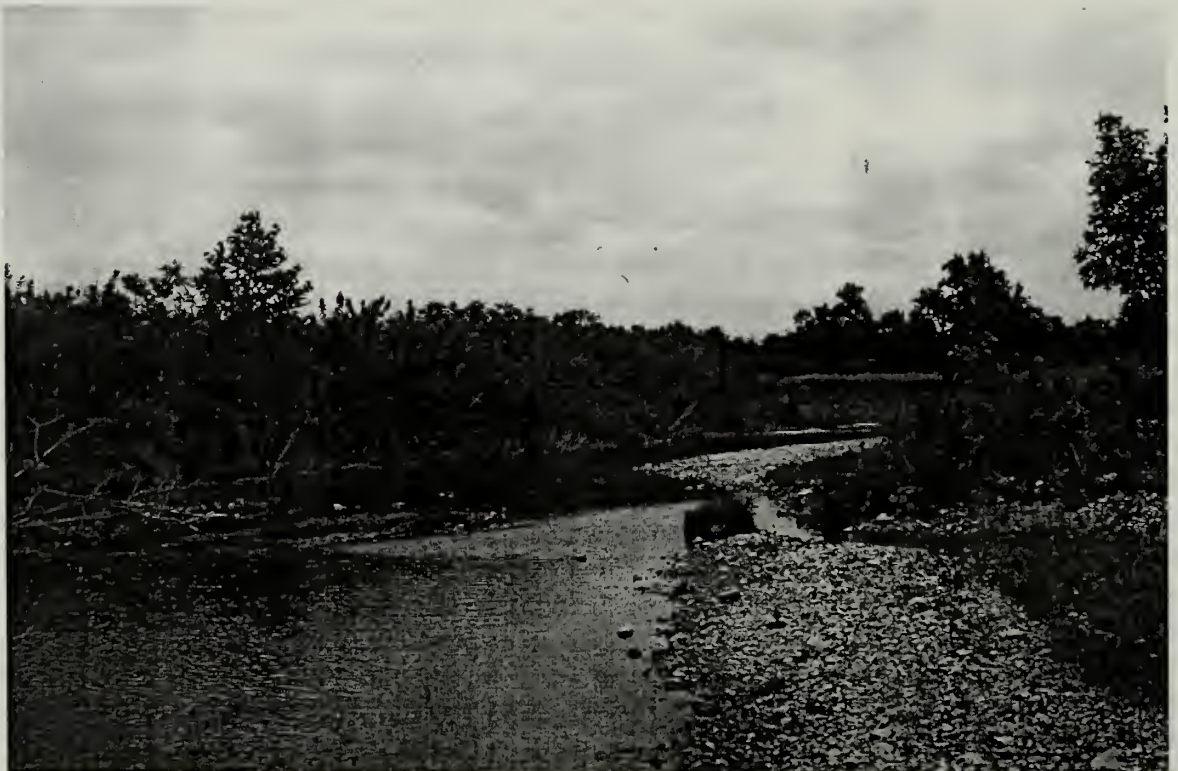
**Photo 32: View downstream of the Calf Creek Site (2000).**

**Overall Summary** – Stabilization efforts at this site have completely failed along the lower two-thirds and upper third is unraveling. The lower half of the bank has eroded into the agricultural field an additional 60 feet. The thalweg is against the toe of the bank for its entire length. The eroding bank is vertical with little or no vegetation. Only a 150 foot upper portion of the 500 foot revetment remains.

This site demonstrates a number of “don’ts” associated with installation of cedar revetments. It should be noted that for the first three-years of the revetment’s life the bank was recovering quite well. The clay content of the soil and the amount of river cane we transplanted combined to produce a lush growth of vegetation on the bank. However, by the fourth year the cedars were beginning to decay and the negative aspects of this site began to rule. The combination of negative impacts include: 1.) relatively small radius of curvature and high erosion rate, 2.) ongoing substantial disturbances in the watershed (clearing of steep hillsides and riparian zones and in-stream dozing above the park), 3.) the fact that the thalweg remained against the bank. As a result, the point bar opposite the bank continued to accumulate sediment and the thalweg became narrower and ever more aggressive on the bank and even started to under-cut portions of the revetment. Eventually, a half-dozen trees in the lower revetment failed and the entire structure is unraveling due to cutting of the bank behind the lower trees and propagation of this cutting in the upstream direction.

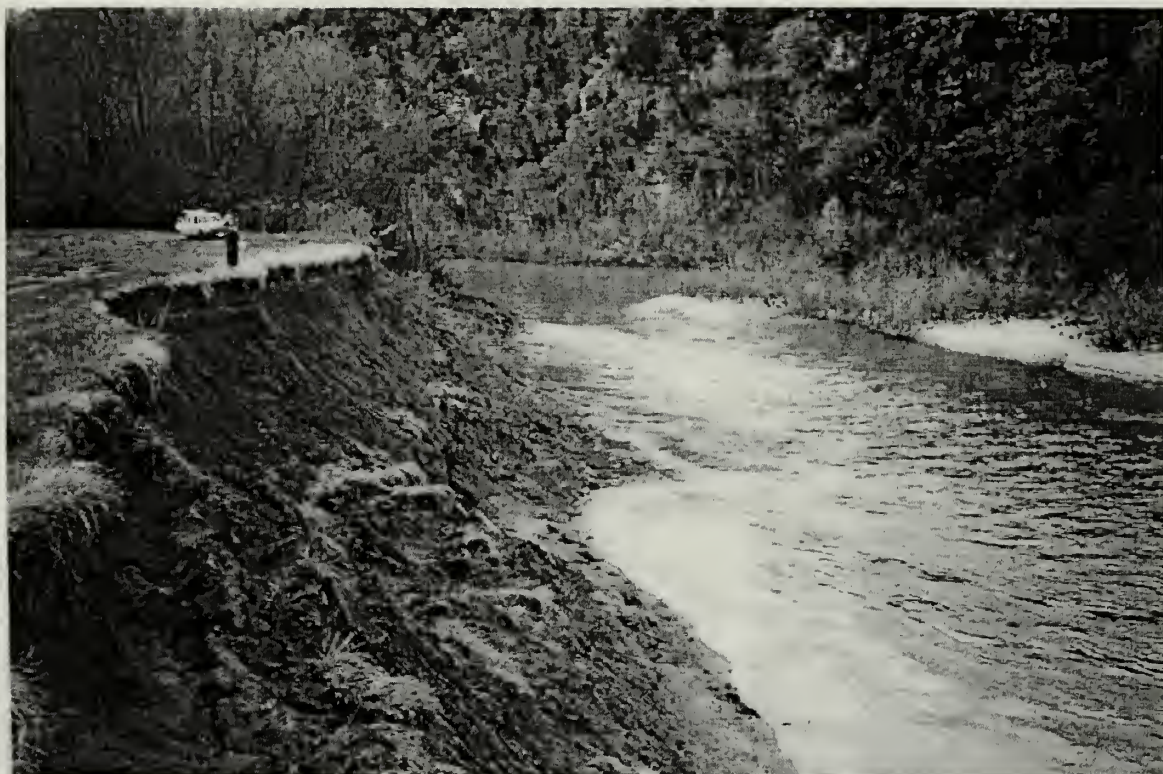
This site is located on the main channel of the Buffalo River down stream of the South Maumee access area. Bank height ranges from 30 to 35 feet and is 800 feet long. Aerial photos indicate 70 to 100 feet of bank have been removed between 1972 and 1992. The above and below stream-side forest is still in-tact but does not extend very far onto the flood plain. More slumping is likely as aggradation continues in the channel and more floods come down the river. One small clump of trees continues to cling to the top of the bank about 2/3 of the way down. The entire channel length visible from the top of the bank is underlain by solid bedrock. The bank is composed of very unconsolidated sand. The channel has a large bluff on the river left and this steep eroding bank on river right. A large gravel bar is forming in the river directly out from this bank that is nearly as long as the bank. On the 1972 aerial photographs it is obvious that the river had overtopped this bank during some relatively recent period of flooding and had scarred the flood plain and torn up the stream-side buffer much like has been observed more recently at Big Creek and the Sheldon Branch Field. This damage to the stream-side forest combined with the removal of the flood plain forest for agriculture probably set this bank up for ultimate slumping. It may be possible that some of the gravel bar formed in front of the bank is partially composed of material transported off the bank during the slumping episode.

**Photo 35: View upstream of the South Maumee Site (1994).**

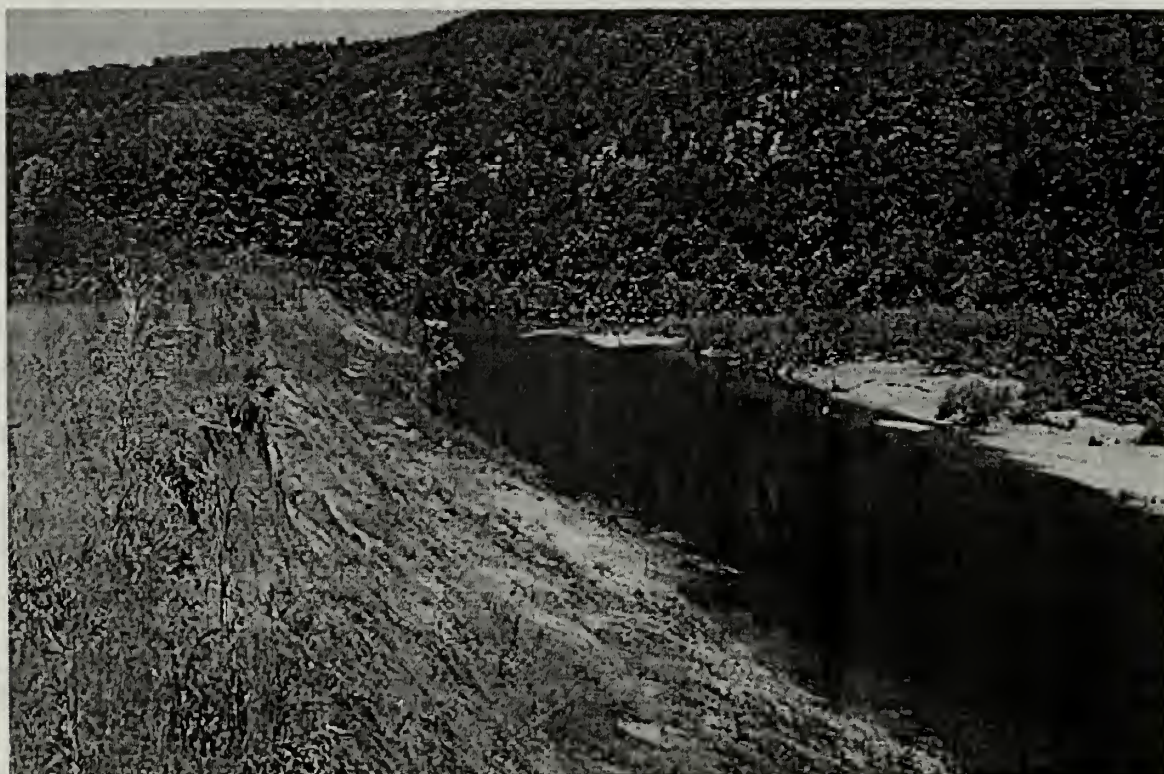
**Photo 36: View upstream of the South Maumee Site (2001).**

**Middle Third** – This portion of the revetment is much like the upper third. There are two cedar trees missing from the upper end of the middle third. The revetment, in the middle third, is completely filled with deposition.

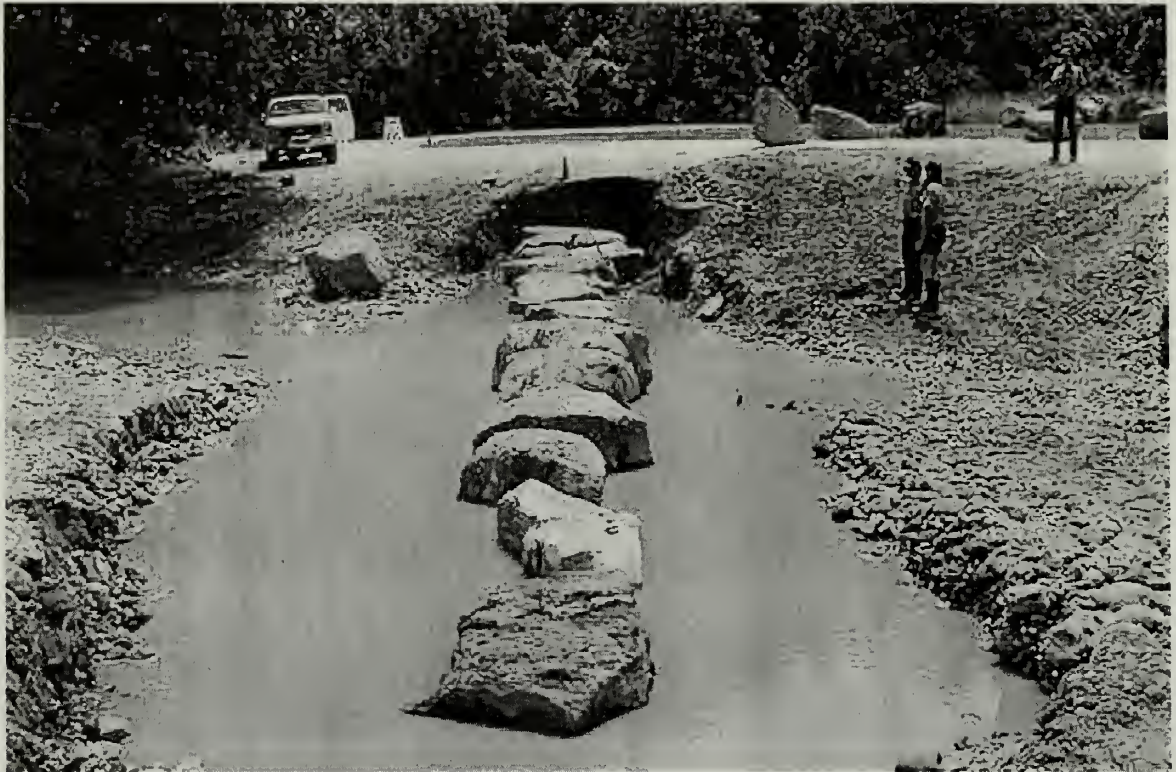
Photo 42: Footer for rock vane looking from midstream, note 30 degree angle from bank.

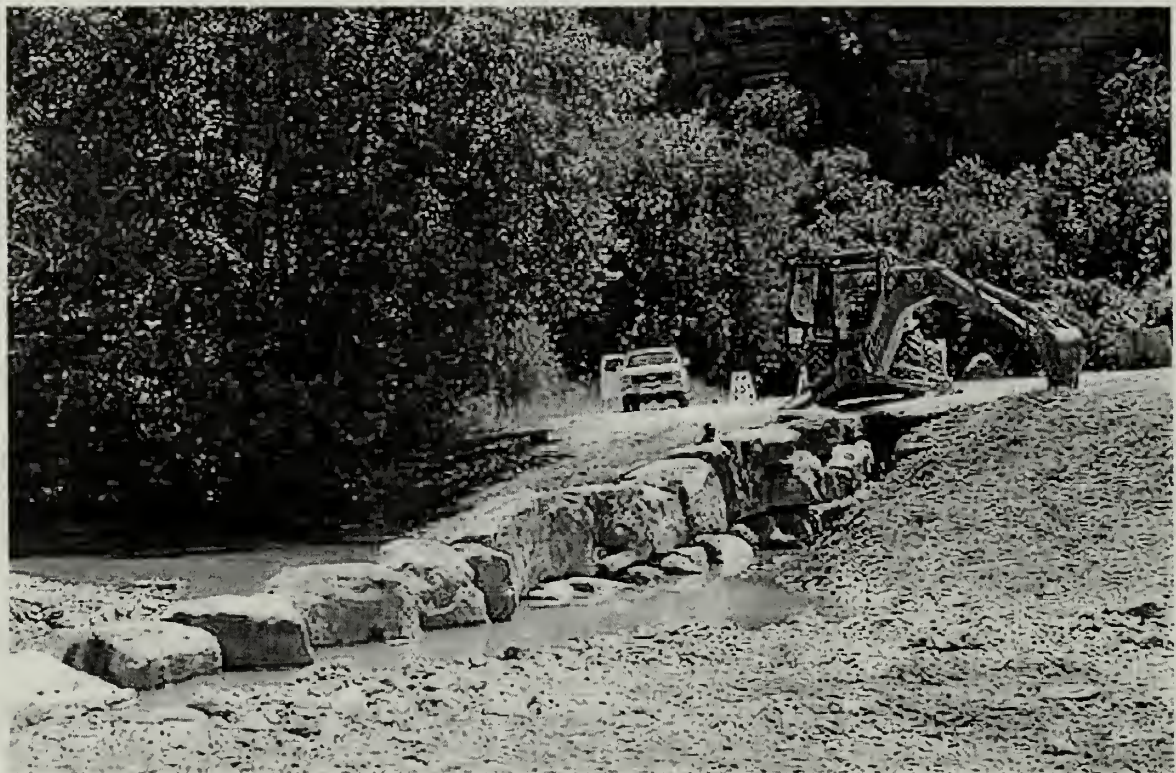
Photo 43: View from upstream of completed vane before backfilling, note 1:10 slope from bankfull into the channel.

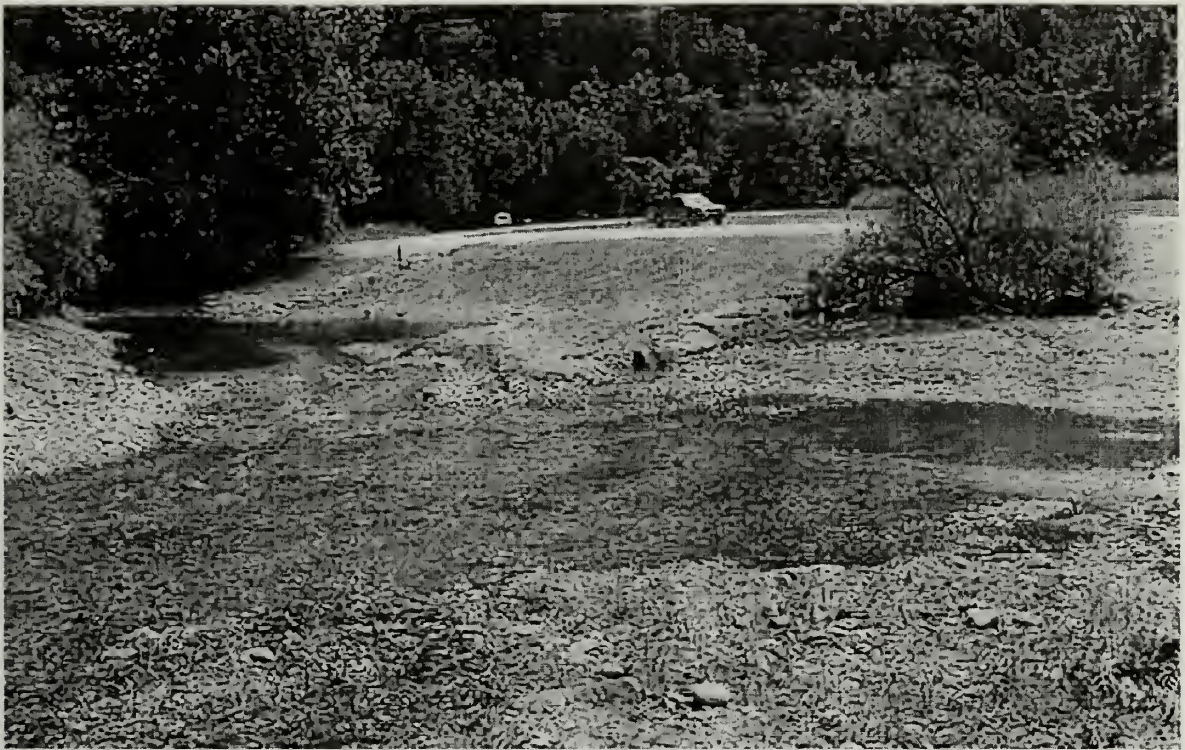
**Photo 44:** View from upstream of completed vanes at Steele Creek launch.

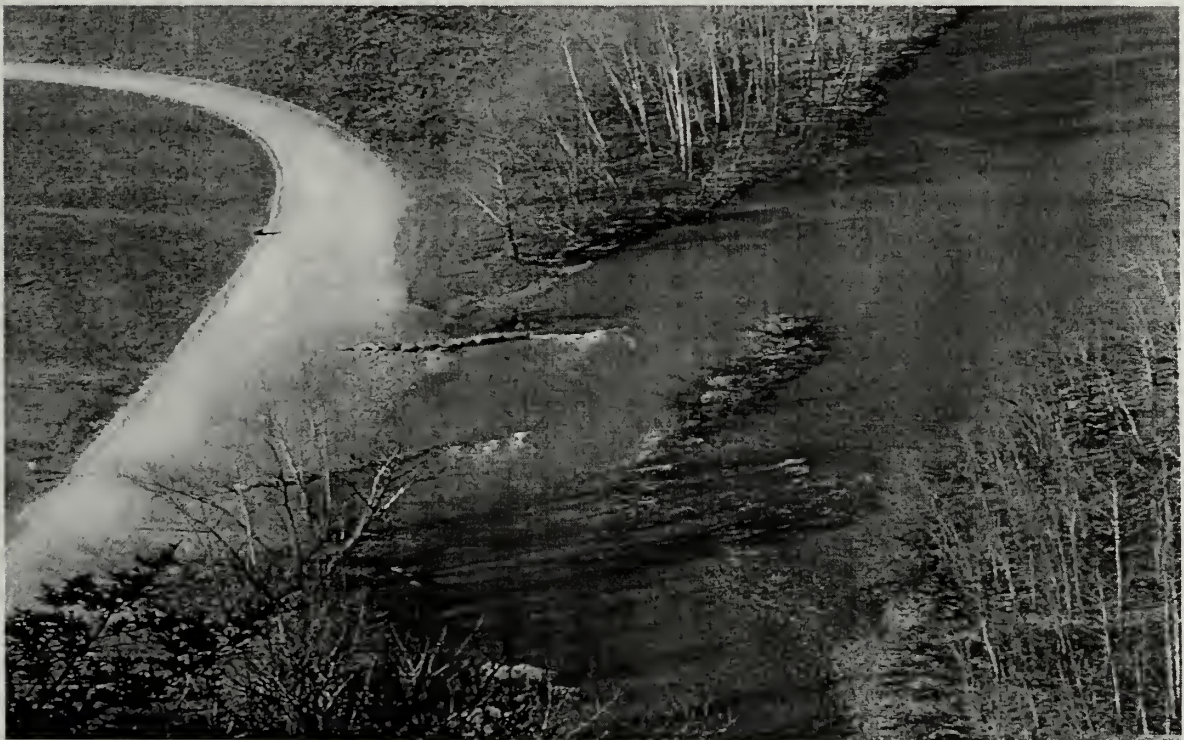
**Photo 45:** View of the Steel Creek rock vanes from Bee Bluff – Dec., 2001; This view shows the major operational factors of the vanes. These are: 1) shifting of the thalweg away from the cut-bank, 2) upstream orientation of the vanes which allows water over-topping the vanes to be directed back toward the channel, 3) tie-in of vanes with the bank-full elevation, and 4) energy dissipation (white water) as the water passes over the vanes, which protects the downstream riparian corridor and bank.
